# The Influence of Applied Stress Ratio on Fatigue Strength of TiN-coated Carbon Steel\*

Kazuaki SHIOZAWA\*\*, Seiichi NISHINO\*\*  
and Keiichi HANDA\*\*\*

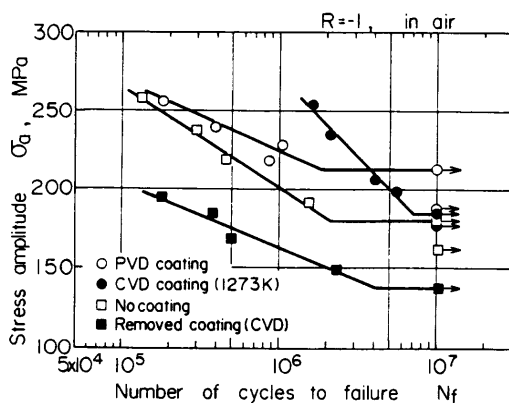
Fig. 7 S-N diagram under  $R=-1$  in air

Figure 7 shows experimental results obtained from the fatigue tests performed under the condition of a stress ratio of  $R = -1$ . It can be seen from this figure that fatigue strength of coated specimens increased under all of the stress amplitude levels, as compared with that of uncoated specimens, and in contrast to the experimental results mentioned above. About 18% and 4% increases in fatigue limit were observed in PVD- and CVD-coated specimens, respectively, as compared with uncoated specimens. In Fig. 7, the experimental results obtained from the tests using the specimen with the CVD coating film removed by electropolish, are also shown. Fatigue strength of this specimen is smaller than that of the uncoated specimen, because of structural change due to the high temperature used in the CVD coating process. To discuss the effect of CVD coating film on the fatigue strength, it is reasonable to compare the results obtained from the specimen coated by CVD

with those treated at the same temperature by the CVD process. From this point of view, the fatigue limit of CVD-coated specimens is improved about 37% as compared with that of specimens with the coating film removed.

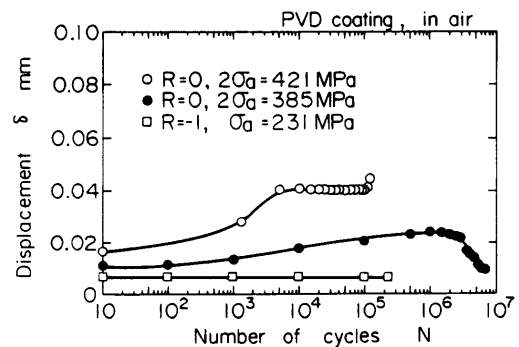
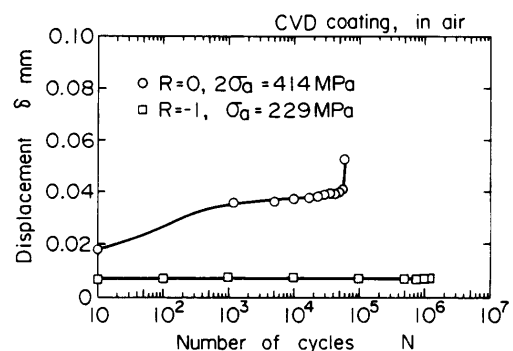
Fig. 8 Variation in deformation during fatigue

In order to discuss the effects of stress ratio and stress level, cyclic deformation behavior of the specimen was measured by extensometer. Figure 8 shows the variation in cyclic deformation of PVD- and CVD-coated specimens. It can be seen from these figures that displacement between the edge of the notch increased during the fatigue process under testing conditions where  $R=0$  and at  $2\sigma_a$  above 390 MPa of PVD and CVD, which were the conditions where fatigue strength decreased. On the other hand, under testing conditions where  $R=0$  and at  $2\sigma_a$  below 390 MPa and  $R=-1$ , which were the conditions where fatigue strength increased, the displacement did not increase. From these results, it is clear that fatigue strength of coated specimens depends on deformation behavior and is closely related to flaws in the coating film, because flaw on the coating film occur at small strain levels.

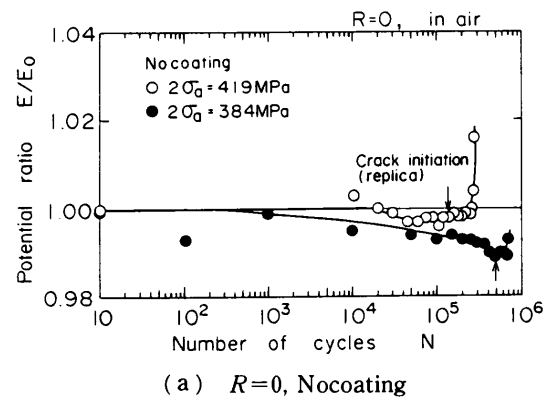
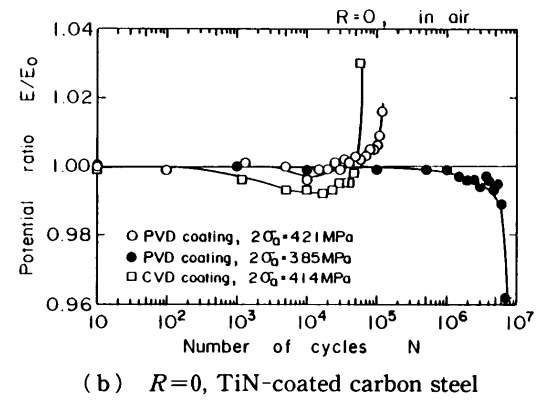
Fig. 10 Variation in potential ratio,  $E/E_0$ , during fatigue

Figure 10 shows the variation in potential ratio  $E/E_0$  during the fatigue process, where  $E_0$  is an average value of the potential in the first 10 cycles, and the arrows in these figures show the number of cycles to crack initiation, obtained from the observations of

replicas. It can be seen from Fig.10(a) that  $E/E_0$  increased after the cycle of crack initiation. Thus, the variation in  $E/E_0$  is correlated with crack initiation and propagation behavior. Figures 10(b) and (c) show the variation in  $E/E_0$  of coated specimens under testing conditions of stress ratios of  $R=0$  and  $R=-1$ , respectively. It can be seen from Fig. 10(b) that  $E/E_0$  increased before the crack initiation of the uncoated specimen, except under testing conditions where  $2\sigma_a=385$  MPa of PVD. Under the former conditions, fatigue strength decreased and under the latter conditions, fatigue strength increased. In Fig.10(c),  $E/E_0$  of coated specimens increased after the cycle of crack initiation of the uncoated specimen; in this case, fatigue strength increased. It can be seen from these

results that in the case of decreased fatigue strength of coated specimens, the number of cycles to crack initiation was decreased by the coating film. On the other hand, in the case of increased fatigue strength, crack initiation was delayed by the coating film.

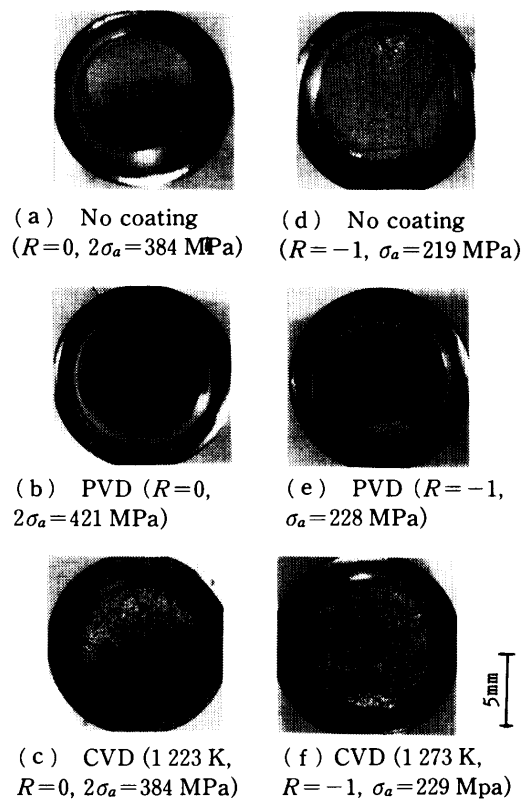
Fig. 11 Macroscopic observation of fracture surface

Figure 11 shows macroscopic observations of the fracture surface of the tested specimen. Under the condition of decreased fatigue life, the number of ratchet marks on the fracture surface of the coated material, which are the result of multiple fatigue crack origins, is larger than that of the uncoated specimen. On the other hand, this number was less than that of the uncoated specimen, under the condition of increased fatigue life.

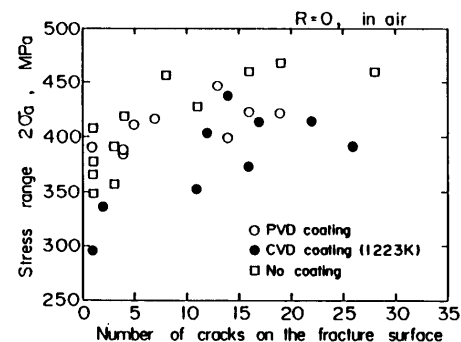
Fig. 12 Relation between stress amplitude and number of cracks on the fracture surface

Figure 12 shows the relationship between stress amplitude and number of cracks on the fracture surface. The number of cracks on the fracture surface of

coated material is larger than that of the uncoated specimens under the testing conditions of a stress ratio of  $R=0$  and high stress amplitude level. On the other hand, the number of cracks is less than that of the uncoated specimen, when  $R=-1$ . It is considered that the number of cracks on the fracture surface is correlated with the fatigue life of the coating film.
