論文

LHDプラズマに曝したステンレス鋼の表面変質とヘリウムの吸蔵・放出

Surface Properties and Retention of Helium in Stainless Steel Exposed to LHD Plasmas

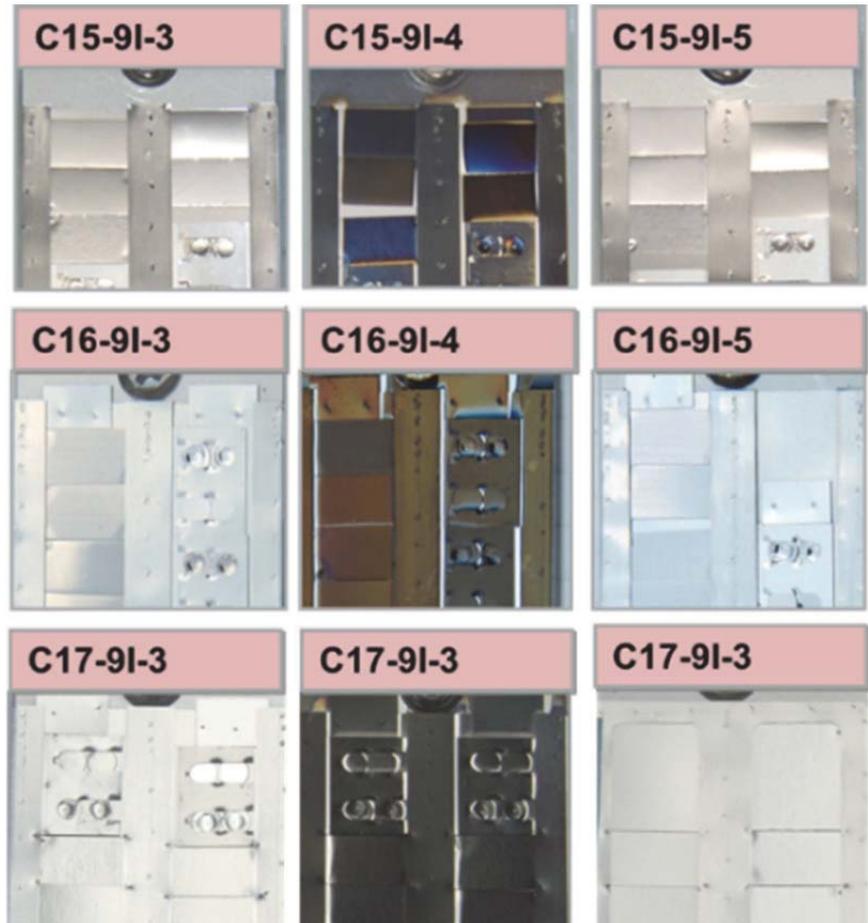
Fig. 2 Pictures of coupons placed near 9I ports in the LHD campaigns C15, C16 and C17.

Pictures of PWI-coupons placed near the 9I port at positions 3, 4 and 5 (Fig. 1) and exposed to the LHD plasmas in the campaigns C15 (2012), C16 (2013) and C17 (2014) are shown in Fig. 2. Some coupons discolored remarkably but others keep well their original metallic gloss. As described later in detail, on the dark area the impurity deposition rate exceeds the erosion rate (position 4), while on the metallic gloss area the inverse situation takes place (positions 3 and 5). In this paper, modification of the plasma-facing surfaces is discussed by classifying into two categories, deposition dominant area (DD area) and erosion dominant area (ED area).
